Regarding washout bridge recently constructed on the Chippewa Valley Branch two and a half miles west of Trevino, Wis., bridge known as M-18½. I have sketched below a section showing heights etc.

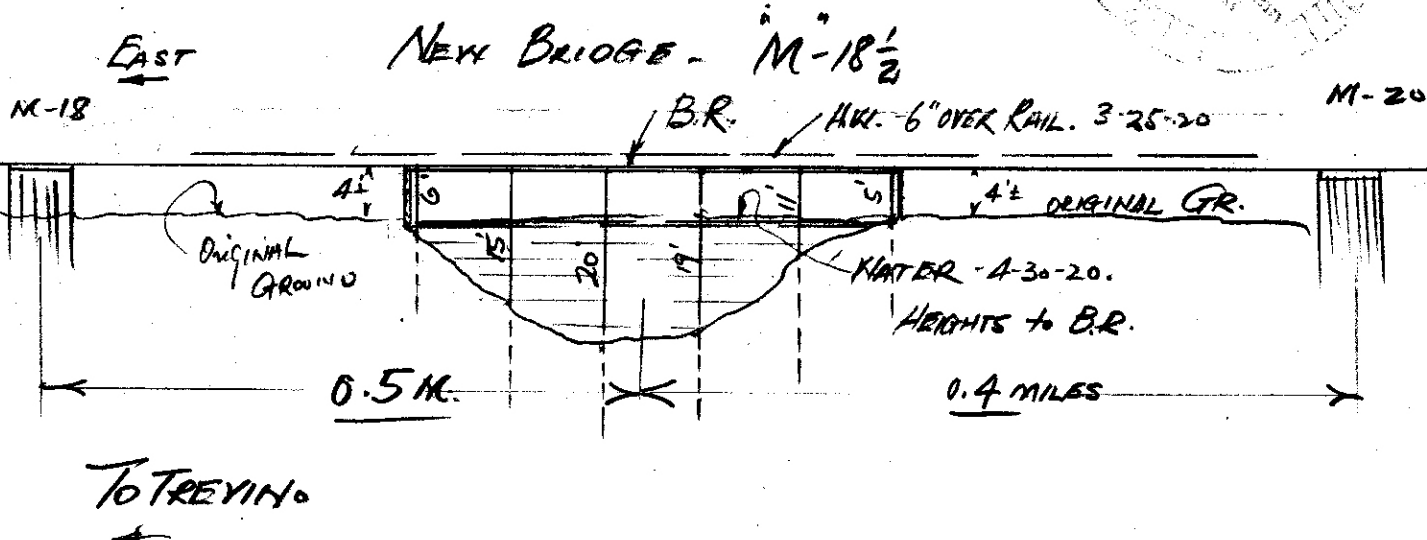
Hole shown scooped out under the bridge is entirely on the Right of Way; R/W here being 100' wide. On March 25th, on account of an ice jam in the Chippewa river to the south (West), water went 6 inches over the track in this vicinity causing this bad hole here and several smaller ones for a quarter of a mile east.

1400± yds req. to fill.

Chief Carpenter Ostrom states that during his time of 13 years water in this locality has never been over the track before but has been up to it several times. He recommends that this bridge be maintained. Bridge is of new material, standard drawing number A-5600.

I agree with Mr. Ostrom; think we should maintain this bridge until time for renewal at least. At that time a further investigation can be made for possible filling.
